**Flood Control Project Maintenance  
Levee Inspections****LMA District Cover Sheet  
Spring 2014 Levee Inspection Results****Reclamation District No. 2060 Hastings**

**Levee Inspection Report By Mile - Spring 2014**

**Reclamation District No. 2060 Hastings**

Waterway	Bank	Unit Miles	Inspection Start/End	Inspector
Unit No. 01 Lindsey Slough	Left	6.94	04/03/2014 04/03/2014	Herman Phillips

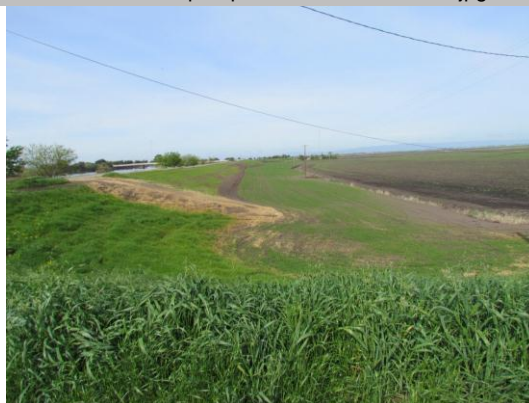
Photo 1 of 1 : phillips\_s\_20140603\_06014.jpg

LM Start	0.00	Rating **	M	Issue No.	467
LM End	0.00	Issue Type +	Ma	Location *	LS
Category	Earthen Levee			GPS Latitude/Longitude	
				Start	End
Item	Vegetation			38.247483 °	38.247483 °
				-121.696291 °	-121.696291 °
DWR ID	DWR_RD2060_01_s _ 2014_467				
Action/Comments					
Control annual grass and weeds on the levee slopes and easements.

Looking downstream from levee mile 0.00 landside slope of RD 2060.  
Photo taken 03-04-2014

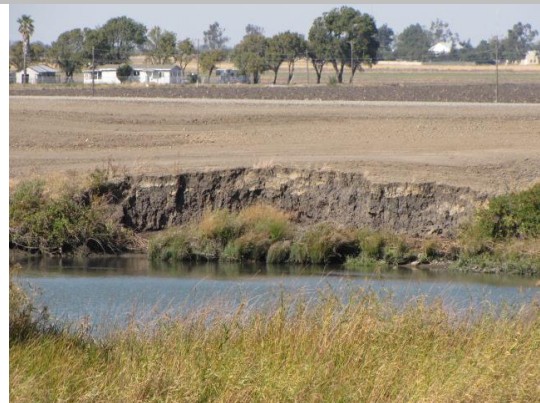
Photo 1 of 1 : phillips\_s\_20140306\_655.JPG

LM Start	2.40	Rating **	U	Issue No.	17
LM End	2.40	Issue Type +	Ma	Location *	WS
Category	Earthen Levee			GPS Latitude/Longitude	
				Start	End
Item	Erosion / Bank Caving			38.259254 °	38.259254 °
				-121.727257 °	-121.727257 °
DWR ID	DWR_RD2060_01_s_2013_17				
Action/Comments					
Schedule repair of erosion site prior to the next inspection. Inspector Comments: District is aware of the problem, they are scheduling the area to be repaired 2014.

From RD 536 Looking across channel at RD 2060 Unit 1 erosion site levee mile 2.40 scour hole up to 20' deep and more than 50 feet across. Photo taken 10-08-2013. This erosion site is still active, District has it scheduled for repairs 2014.

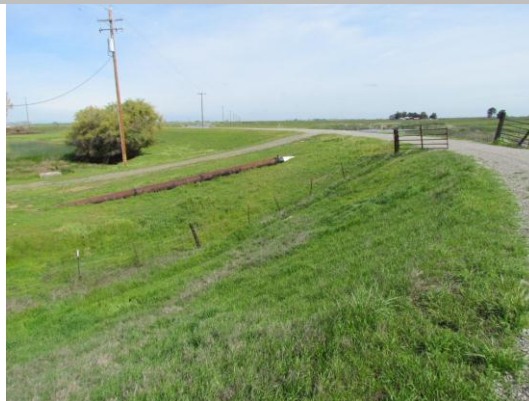
Photo 1 of 1 : phillips\_s\_20140603\_06015.jpg

LM Start	0.00	Rating **	A	Issue No.	192
LM End	0.00	Issue Type +	Ma	Location *	LS
Category	Earthen Levee			GPS Latitude/Longitude	
				Start	End
Item	Vegetation			38.274841 °	38.274841 °
				-121.794855 °	-121.794855 °
DWR ID	DWR_RD2060_02_s _ 2014_192				
Action/Comments					
Control annual grass and weeds on the levee slopes and easements.

Looking downstream from levee mile 0.00 Unit 2 landside levee slope.  
Photo taken 03-04-2014.

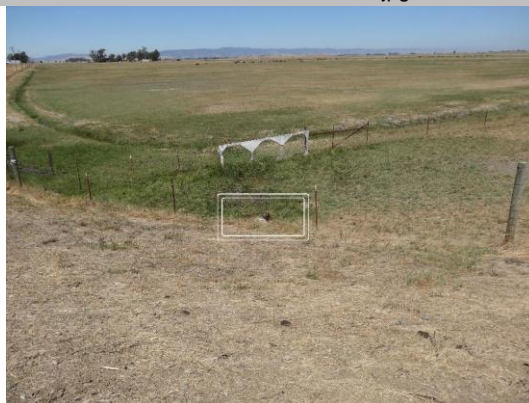
Photo 1 of 1 : UCIP\_1691.jpg

LM Start	1.77	Rating **	M	Issue No.	190
LM End	1.77	Issue Type +	En	Location *	WS
Category	Supplemental			GPS Latitude/Longitude	
				Start	End
Item	DWR UCIP Field Study			38.285219 °	38.285219 °
				-121.777085 °	-121.777085 °
DWR ID	DWR_RD2060_02_s_2014_190				
Action/Comments					
Inspector Comments: FS_ID:18386					
EP_NO: 10148					
Repair Type:					
Crossing Status:					
UCIP Comments: U-type concrete headwall on LS. Not accessible due to fence. Vegetation is partially blocking inlet & outlet pipe.					
FIELD_STRUCT_DESC: 24-inch CM drainpipe through levee, 16.0 feet below crown, flap gate on waterward end. U-type concrete headwall on LS. Not accessible due to fence. Vegetation is partially blocking inlet & outlet pipe.					
FS Date: 8/15/2013

WS view: overview of CMP from levee.

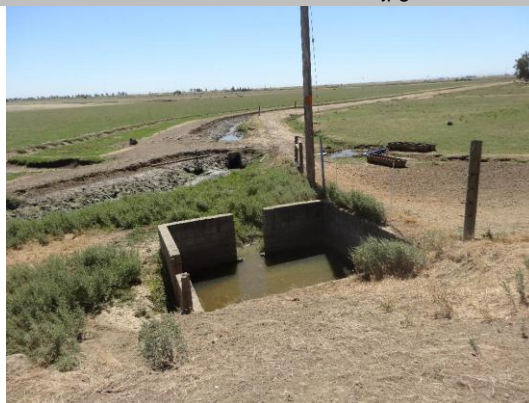
Photo 1 of 1 : UCIP\_1703.jpg

LM Start	2.09	Rating **	M	Issue No.	191
LM End	2.09	Issue Type +	En	Location *	LS
Category	Supplemental			GPS Latitude/Longitude	
				Start	End
Item	DWR UCIP Field Study			38.289474 °	38.289474 °
				-121.775914 °	-121.775914 °
DWR ID	DWR_RD2060_02_s_2014_191				
Action/Comments					
Inspector Comments: FS_ID:18528					
EP_NO: N/A					
Repair Type:					
Crossing Status:					
UCIP Comments: - Abandoned pump structure in stream and concrete distribution box on landside. Not accessible due to wired fence.					
Needs proper abandonment.					
FIELD_STRUCT_DESC: Abandoned pump structure in stream and a concrete distribution on landside. Not accessible due to wired fence.					
FS Date: 8/15/2013

LS view: abandoned concrete distribution box. Not accessible due to wire fence.

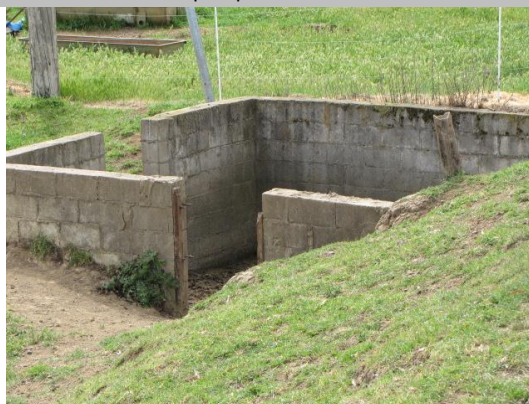
Photo 1 of 1 : phillips\_s\_20140306\_277.JPG

LM Start	2.10	Rating **	M	Issue No.	4
LM End	2.10	Issue Type +	En	Location *	LS
Category	Earthen Levee			GPS Latitude/Longitude	
				Start	End
Item	Encroachments			38.290085 °	38.290085 °
				-121.775486 °	-121.775486 °
DWR ID	DWR_RD2060_02_s_2013_4				
Action/Comments					
Wall					
Inspector Comments: Abandoned concrete structure at this location this was once used as a pump site.

This old block structure not in use was placed within the levee section. Photo taken 3-28-2013. No new photo of site during Spring Inspection 03-04-2014.

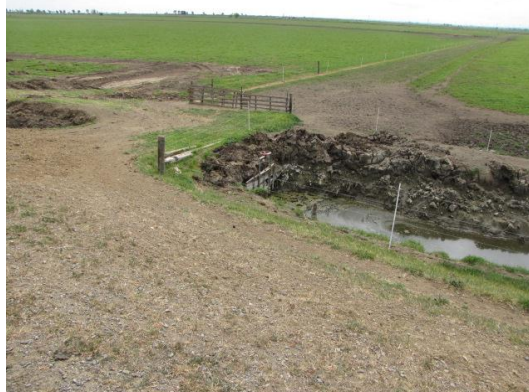
Photo 1 of 1 : phillips\_s\_20140306\_278.JPG

LM Start	2.26	Rating **	M	Issue No.	6
LM End	2.26	Issue Type +	En	Location *	LS
Category	Earthen Levee			GPS Latitude/Longitude	
				Start	End
Item	Encroachments			38.290475 °	38.290475 °
				-121.773390 °	-121.773390 °
DWR ID	DWR_RD2060_02_s _ 2013_6				
Action/Comments					
Ditch

This ditch encroaches within the 10-foot easement. Photo taken 3-28-2013. No new photo was taken of this ditch during the Spring Inspection of 2014.

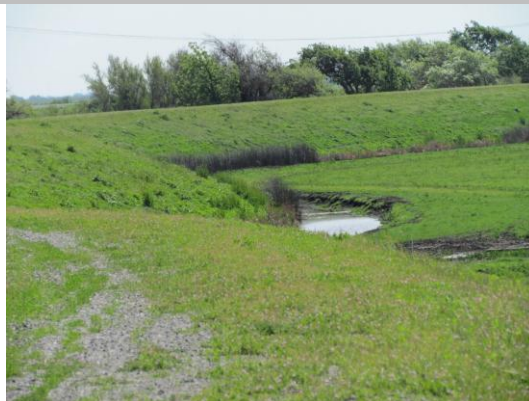
Photo 1 of 1 : phillips\_s\_20140603\_06016.jpg

LM Start	0.00	Rating **	M	Issue No.	7
LM End	0.00	Issue Type +	Ma	Location *	LS
Category	Earthen Levee			GPS Latitude/Longitude	
				Start	End
Item	Vegetation			38.296651 °	38.296651 °
				-121.748801 °	-121.748800 °
DWR ID	DWR_RD2060_03_s _ 2012_7				
Action/Comments					
Remove the wild growth other than native grasses from the levee slopes.

Looking downstream from the landside levee slope levee mile 0.00 Unit 3.

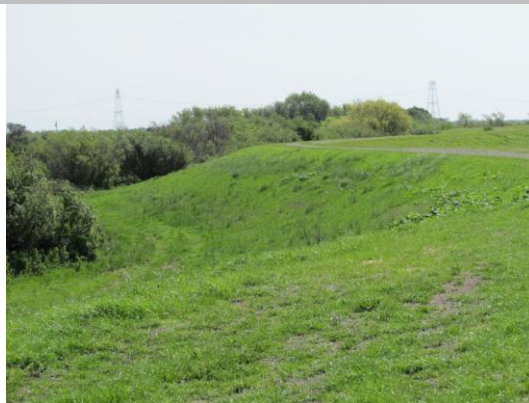
Photo 1 of 1 : phillips\_s\_20140603\_06017.jpg

LM Start	0.00	Rating **	A	Issue No.	171
LM End	0.00	Issue Type +	Ma	Location *	WS
Category	Earthen Levee			GPS Latitude/Longitude	
				Start	End
Item	Vegetation			38.296651 °	38.296651 °
				-121.748801 °	-121.748801 °
DWR ID	DWR_RD2060_03_s _ 2014_171				
Action/Comments					
Control annual grass and weeds on the levee slopes and easements.

Looking downstream from levee mile 0.00 Unit 3 waterside levee slope.

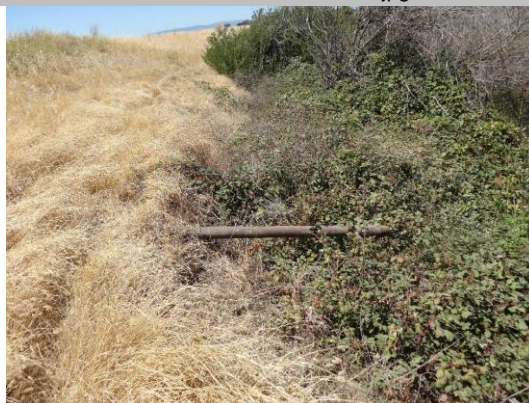
Photo 1 of 1 : UCIP\_1729.jpg

LM Start	0.90	Rating **	M	Issue No.	168
LM End	0.90	Issue Type +	En	Location *	WS
Category	Supplemental			GPS Latitude/Longitude	
				Start	End
Item	DWR UCIP Field Study			38.290684 °	38.290684 °
				-121.735668 °	-121.735668 °
DWR ID	DWR_RD2060_03_s_2014_168				
Action/Comments					
Inspector Comments: FS_ID:18727					
EP_NO: N/A					
Repair Type:					
Crossing Status:					
UCIP Comments: Seem abandoned. Not found- pump on LS. Needs more exploration.					
FIELD_STRUCT_DESC: 6-inch steel pipe through the levee, 2.8 feet below the crown. O&M Manual SAC 107, April 1959.					
FS Date: 8/15/2013

Waterside view: levee slope and a steel pipe.

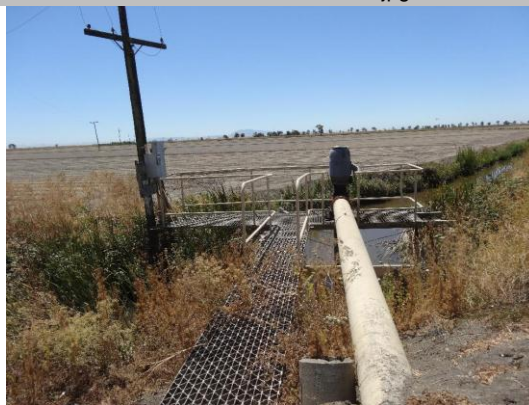
Photo 1 of 1 : UCIP\_1727.jpg

LM Start	0.90	Rating **	M	Issue No.	169
LM End	0.90	Issue Type +	En	Location *	WS
Category	Supplemental			GPS Latitude/Longitude	
				Start	End
Item	DWR UCIP Field Study			38.290684 °	38.290684 °
				-121.735639 °	-121.735639 °
DWR ID	DWR_RD2060_03_s_2014_169				
Action/Comments					
Inspector Comments: FS_ID:18726					
EP_NO: 6342					
Repair Type:					
Crossing Status:					
UCIP Comments: Leaky siphon breaker may need to be repaired.					
Dense vegetation on WS. Not found- gate valve on LS.					
FIELD_STRUCT_DESC: 16-inch steel pipe through levee 8.0 feet below crown, vertical pump in drain ditch on land-side. Siphon breaker on waterside. (App. No. 6342-A - Hastings Farms)					
FS Date: 8/15/2013

Landside view: pump, service pole, steel support structure, walkway, and pipe.

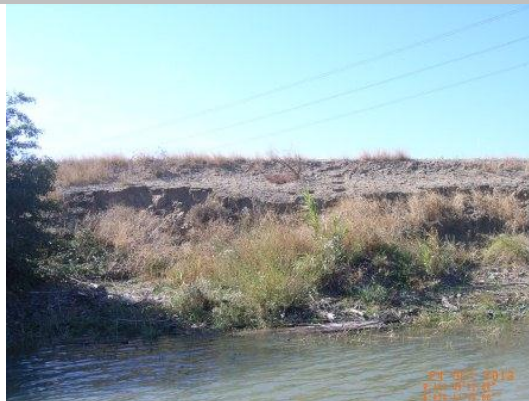
Photo 1 of 1 : USACE2013A\_CHS\_23-6\_R\_2.jpg

LM Start	1.51	Rating **	M	Issue No.	10
LM End	1.60	Issue Type +	Ma	Location *	WS
Category	Supplemental			GPS Latitude/Longitude	
				Start	End
Item	USACE Erosion Survey			38.288598 °	38.286051 °
				-121.725184 °	-121.722818 °
DWR ID					
Action/Comments					
Inspector Comments: Site added in 1997 and removed in 2003. 2005 - Put back in the inventory. 2006 - Stone repair at the middle of the site. 2011 - Some rock place at toe in the past year. 2013: Site extended both upstream and downstream to include new erosion pockets. [2013 Site ID: CHS_23-6_R]

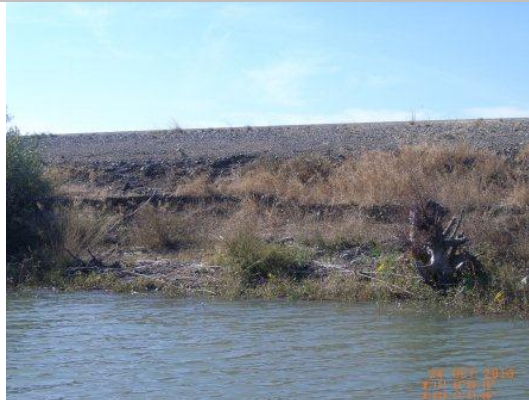
Photo 1 of 1 : USACE2013A\_CHS\_23-0\_R\_1.jpg

LM Start	1.96	Rating **	M	Issue No.	9
LM End	2.08	Issue Type +	Ma	Location *	WS
Category	Supplemental			GPS Latitude/Longitude	
				Start	End
Item	USACE Erosion Survey			38.284105 °	38.283302 °
				-121.718471 °	-121.717814 °
DWR ID					
Action/Comments					
Inspector Comments: 2010 - Small maintenance site. 2013: No observed changes. [2013 Site ID: CHS 23-0 R]

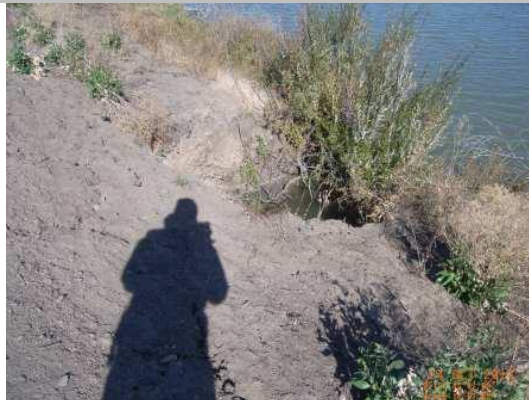
Photo 1 of 1 : USACE2013A\_CHS\_22-9\_R\_1.jpg

LM Start	2.11	Rating **	M	Issue No.	8
LM End	2.17	Issue Type +	Ma	Location *	WS
Category	Supplemental			GPS Latitude/Longitude	
				Start	End
Item	USACE Erosion Survey			38.282847 °	38.282245 °
				-121.717549 °	-121.717058 °
DWR ID					
Action/Comments					
Inspector Comments: 2013: Pockets of ersoion behind willows. [2013 Site ID: CHS_22-9 R]

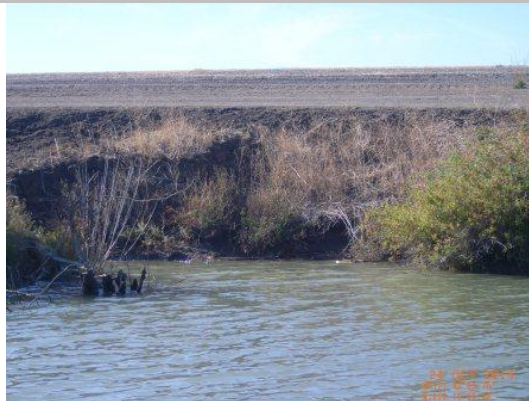
Photo 1 of 1 : USACE2013A\_CHS\_22-8\_R\_4.jpg

LM Start	2.18	Rating **	M	Issue No.	6
LM End	2.24	Issue Type +	Ma	Location *	WS
Category	Supplemental			GPS Latitude/Longitude	
				Start	End
Item	USACE Erosion Survey			38.282069 °	38.281482 °
				-121.716891 °	-121.716356 °
DWR ID					
Action/Comments					
Inspector Comments: 2007 - Geotechnical failure of midside slope and wave wash/scalloping in toe area. Stone revetment upstream and downstream of site. Similar sites are present all along the right bank downstream of this site, most could be repaired with some maintenance. 2010 - Minor new erosion. 2013: No observed changes. [2013 Site ID: CHS 22-8 R]

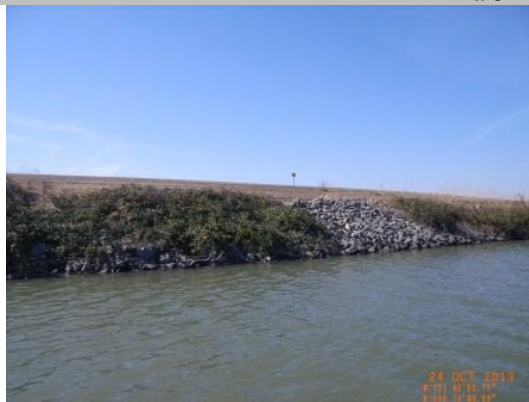
Photo 1 of 1 : USACE2013A\_CHS\_22-6\_R\_2.jpg

LM Start	2.34	Rating **	M	Issue No.	5
LM End	2.53	Issue Type +	Ma	Location *	WS
Category	Supplemental			GPS Latitude/Longitude	
				Start	End
Item	USACE Erosion Survey			38.280356 °	38.278214 °
				-121.714697 °	-121.712857 °
DWR ID					
Action/Comments					
Inspector Comments: 2008 - Small scour pockets and mid-slope wave wash. 2010 - More vegetation growth, could be fixed through maintenance. 2011 - Site extended downstream and new erosion. 2013: No observed changes. [2013 Site ID: CHS 22-6 R]

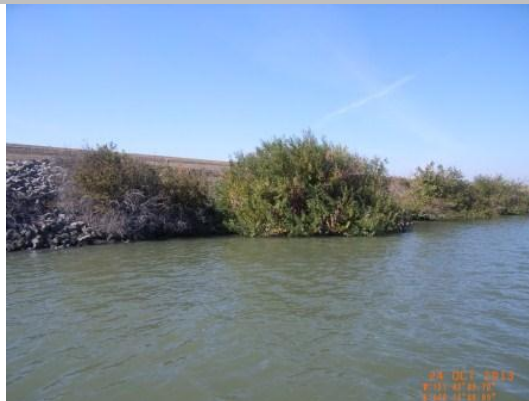
Photo 1 of 1 : USACE2013A\_CHS\_22-5\_R\_1.jpg

LM Start	2.54	Rating **	M	Issue No.	4
LM End	2.58	Issue Type +	Ma	Location *	WS
Category	Supplemental			GPS Latitude/Longitude	
				Start	End
Item	USACE Erosion Survey			38.278109 °	38.277754 °
				-121.712671 °	-121.712144 °
DWR ID					
Action/Comments					
Inspector Comments: 2013: Erosion pockets into the levee toe. [2013 Site ID: CHS_22-5_R]

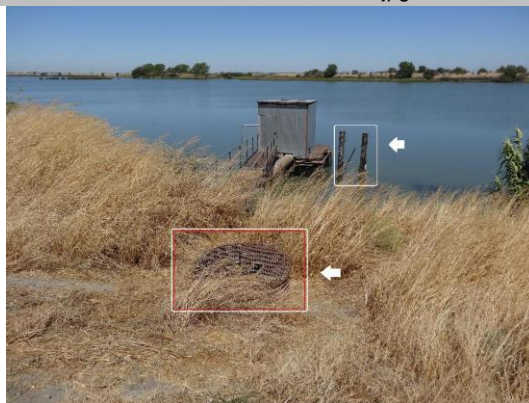
Photo 1 of 1 : UCIP\_1725.jpg

LM Start	3.24	Rating **	M	Issue No.	170
LM End	3.24	Issue Type +	En	Location *	WS
Category	Supplemental			GPS Latitude/Longitude	
				Start	End
Item	DWR UCIP Field Study			38.270151 °	38.270151 °
				-121.705782 °	-121.705782 °
DWR ID	DWR_RD2060_03_s_2014_170				
Action/Comments					
Inspector Comments: FS_ID:18723					
EP_NO: N/A					
Repair Type:					
Crossing Status:					
UCIP Comments: Only a CMP riser was found on WS.					
FIELD_STRUCT_DESC: Only a CMP riser was found WS. All other features not found as described: 36-inch steel pipe through levee 15.0 feet below crown, slide gate in CM riser on waterward slope. (Asbestos bonded pipe.) Pump in pump house on pile structure in stream. Service pole and anchor on landward slope. Only a CMP riser was found WS.					
FS Date: 8/15/2013

WS view: slide gate in CMP riser (bottom- marked) and may be abandoned pile for pump support (marked- right).

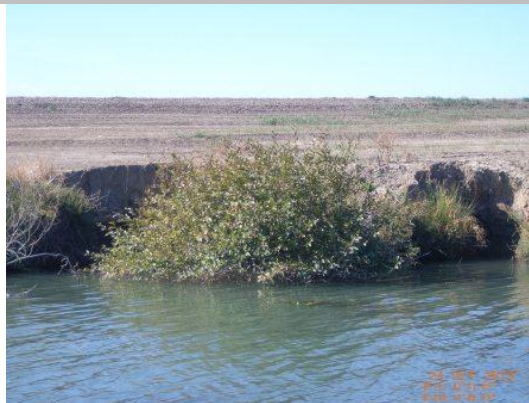
Photo 1 of 1 : USACE2013A\_CHS\_21-1\_R\_12.jpg

LM Start	3.67	Rating **	M	Issue No.	1
LM End	4.08	Issue Type +	Ma	Location *	WS
Category	Supplemental			GPS Latitude/Longitude	
				Start	End
Item	USACE Erosion Survey			38.264585 °	38.260593 °
				-121.698868 °	-121.696403 °
DWR ID					
Action/Comments					
Inspector Comments: 2011 - Several pockets of erosion from rotational failure and slumping toe. 2013: Site extended downstream to include new erosion pockets. [2013 Site ID: CHS_21-1_R]
